NATIONAL BUREAU OF STANDARDS

CIRCULAR OF THE BUREAU OF STANDARDS C450

UNDERGROUND CORROSION

By Kirk H. Logan

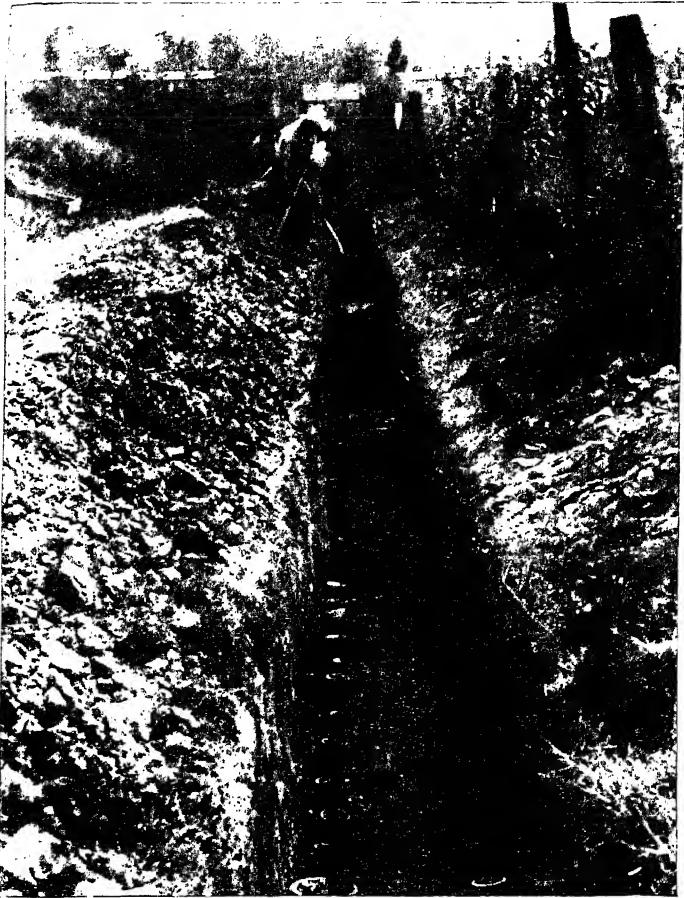
FIGURE 4.—Burial of soil corrosion specimens near Alexandria, Va., in 1932.

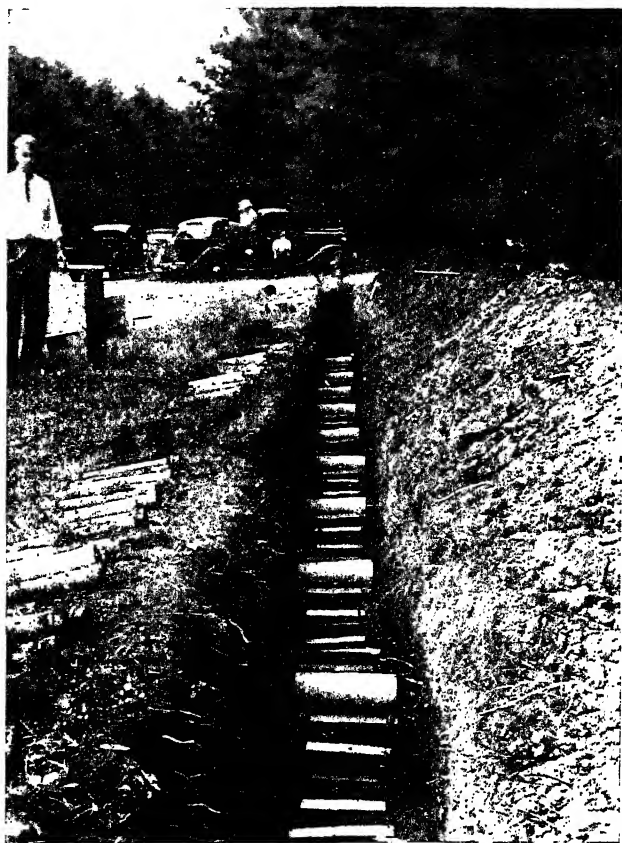
FIGURE 6.—Arrangement of specimens buried near Baltimore, Md., in 1932.

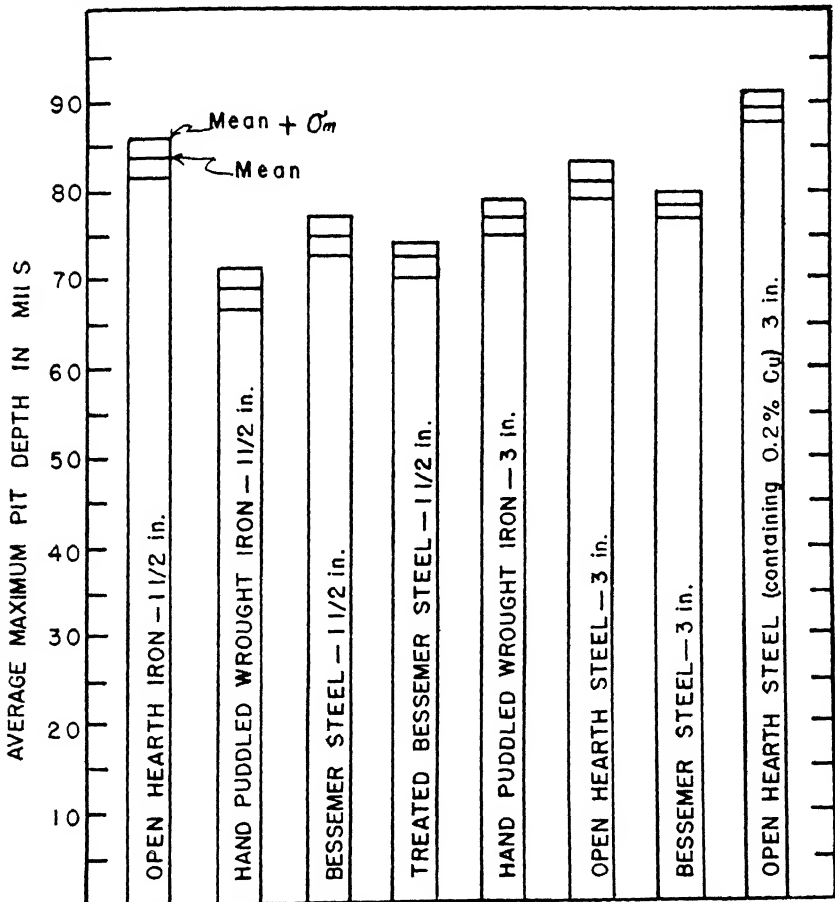
FIGURE 11.—Average maximum pit depth on wrought pipe for 12 years of exposure; 23 soils.

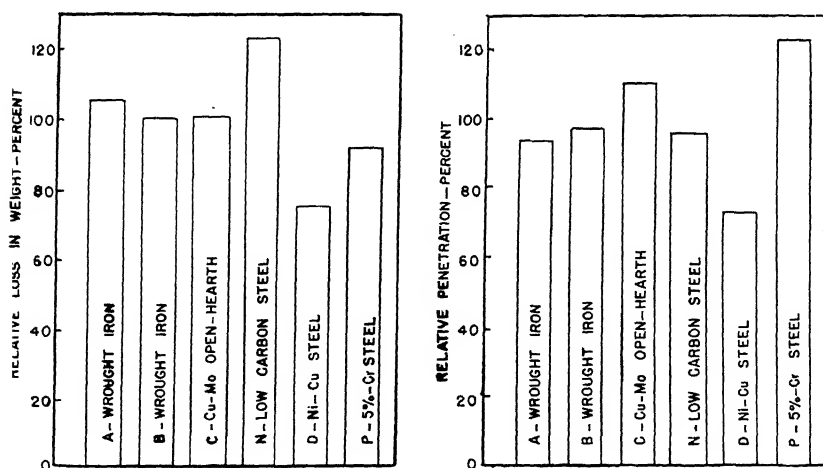
FIGURE 13.—Relative loss of weight and maximum penetration of wrought ferrous for four periods of exposure.

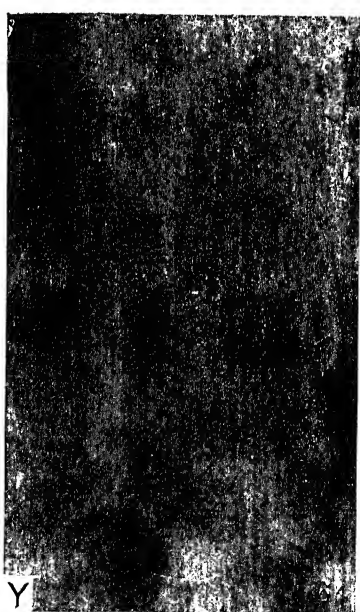
FIGURE 14.—Specimens of high-alloy sheet buried 9 years in Docas clay at Cholame, Calif. (soil 64).

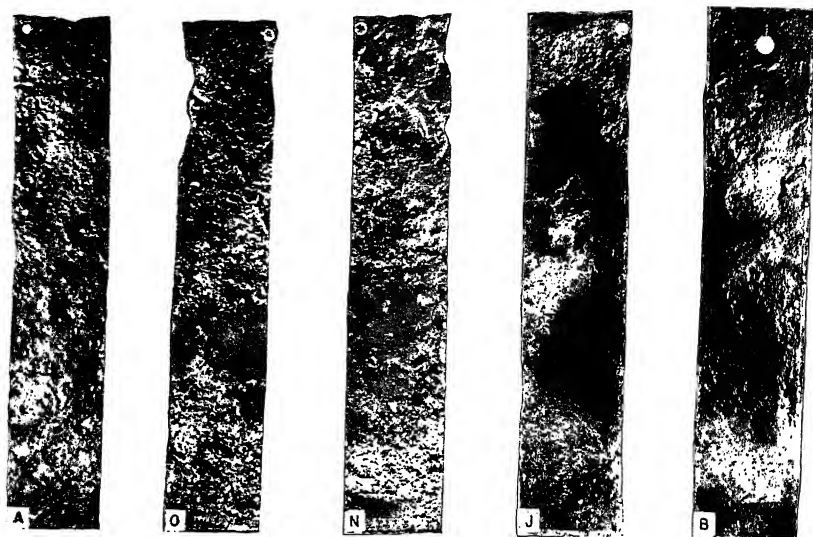
FIGURE 16.—Ferrous plates exposed 4 years to Merced silt loam at Buttonwillow, Calif.

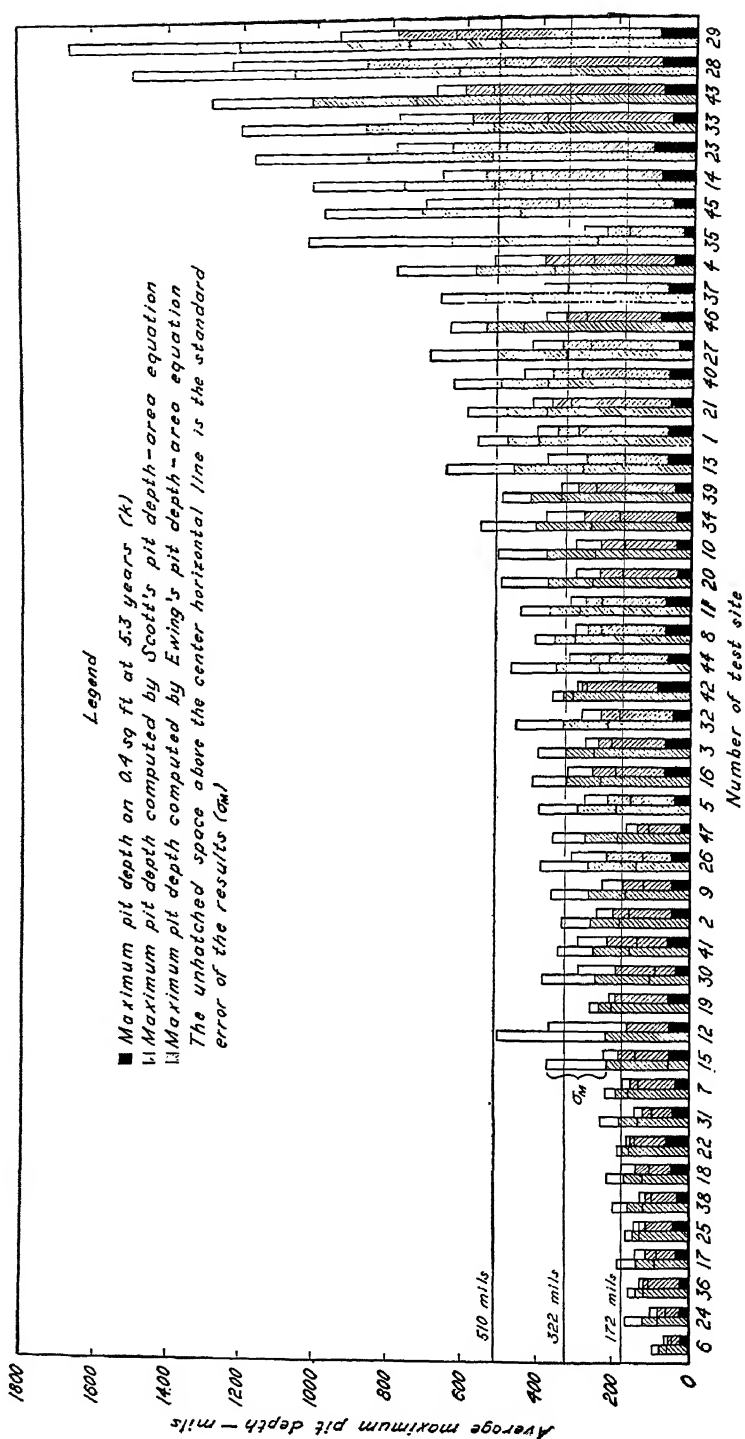
FIGURE 18.—Estimated maximum pit depth on 1,000 feet of 90-year-old 8-inch pipe.

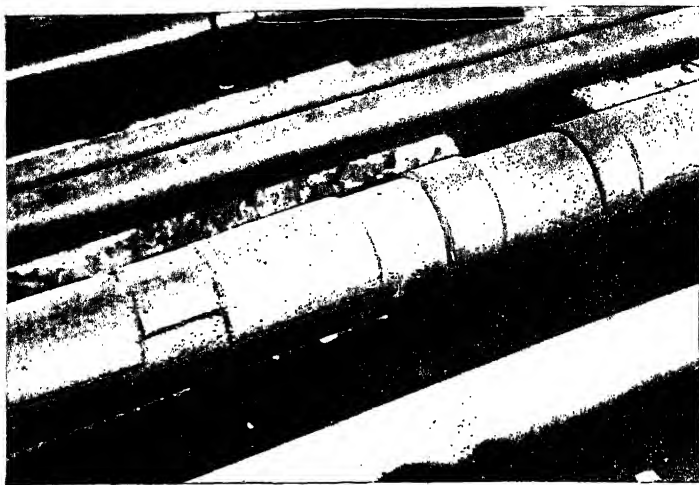
FIGURE 21.—“Half-sole” (welded patch) method of pipe repair.

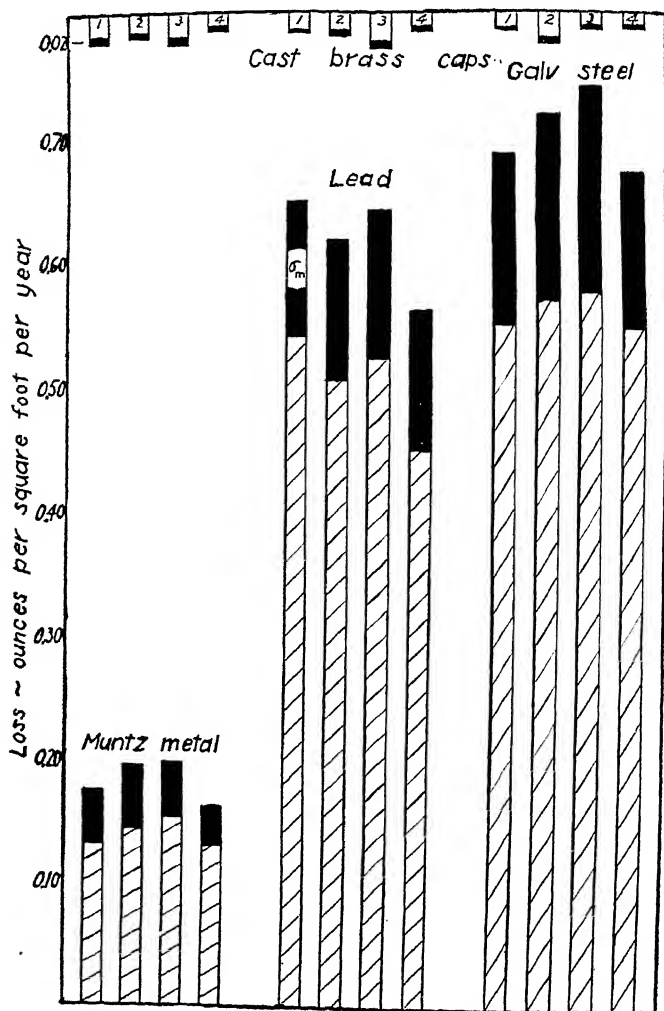
FIGURE 22.—Average rates of corrosion of cast-brass fittings and attached nipples in 15 soils.

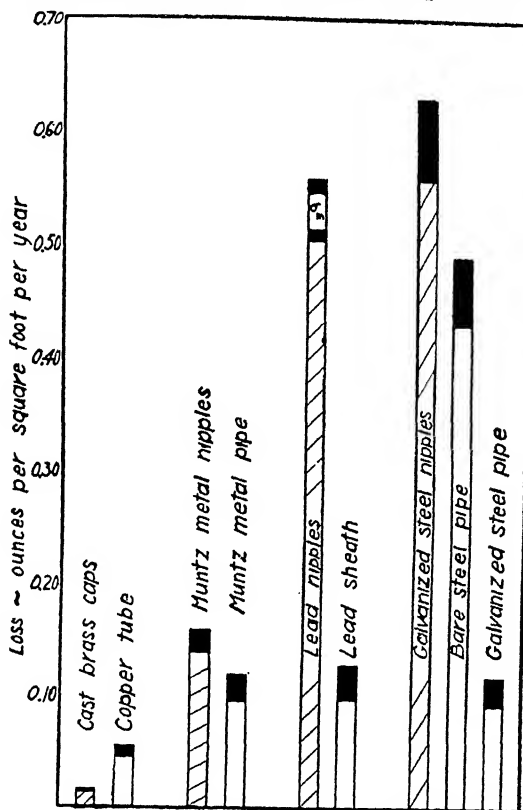
FIGURE 23.—Effect of interconnecting different metals.

each material on all soils. Figure 23 permits a comparison of these losses with losses of similar materials unaffected by galvanic action. It was evident that the connecting of the different materials accelerated the corrosion of the nipples, and reduced the corrosion of the cast caps. The intensity of the galvanic corrosion was affected by the relative areas of

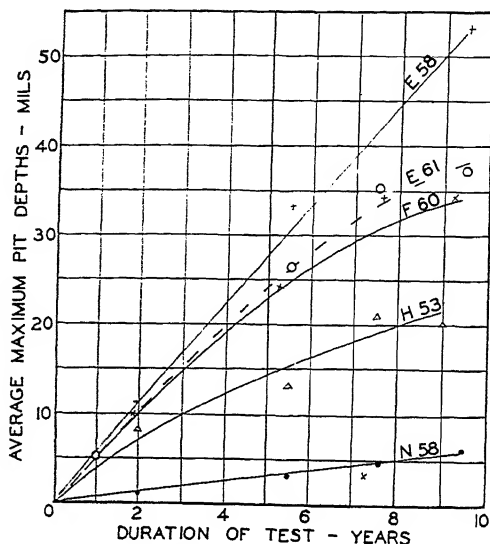
FIGURE 27.—Pit-depth-time curves for several copper-alloy specimens.
See tables 55 and 57 for identification of soils and specimens.

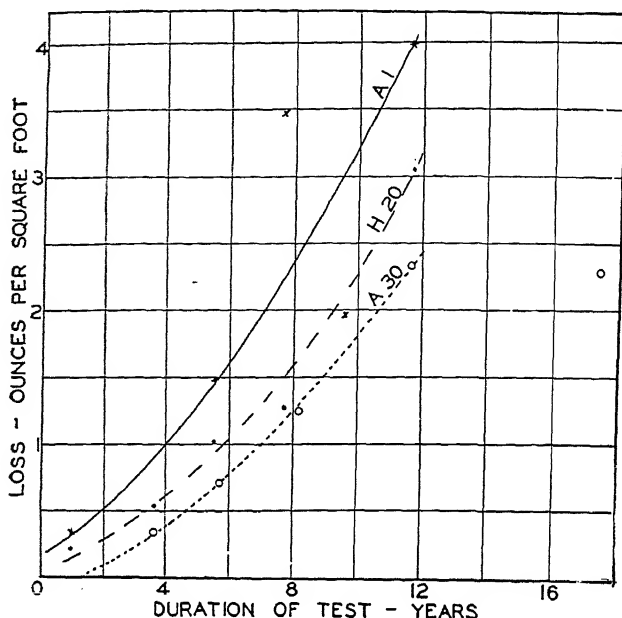
FIGURE 28.—Loss-of-weight-time curves for lead sheath in different soils.

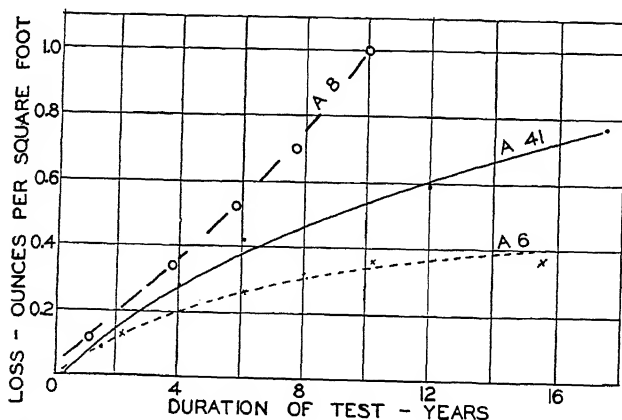
FIGURE 29.—Loss-of-weight-time curves for lead sheath in different soils.

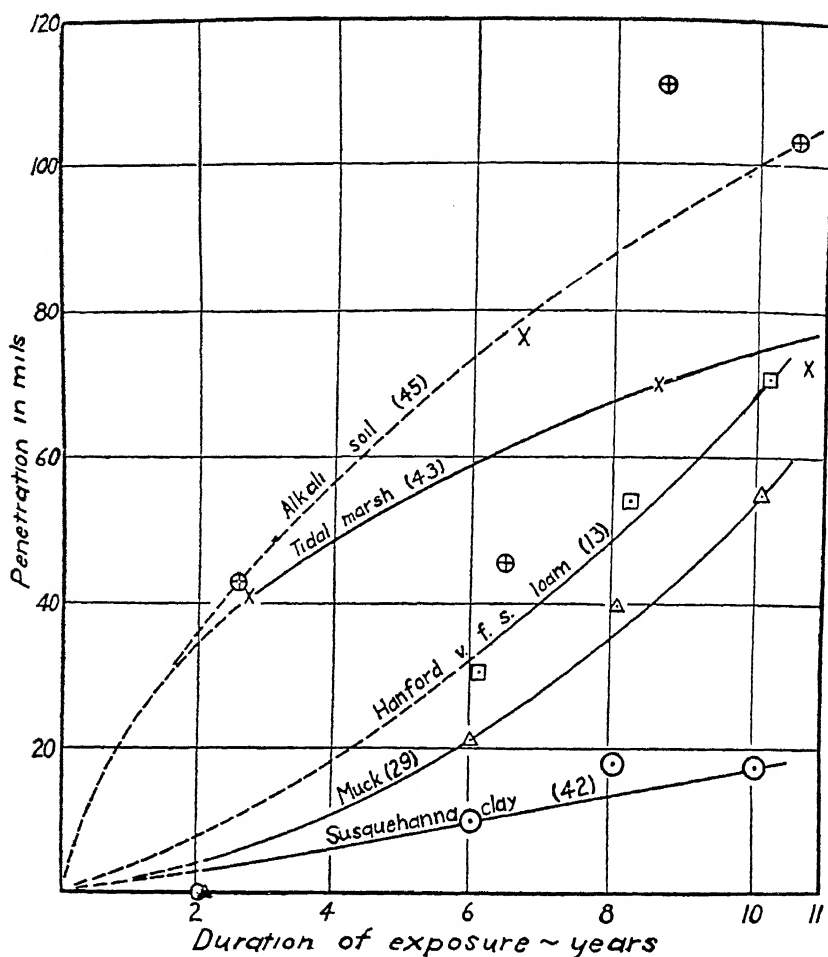
FIGURE 31.—Relation of the maximum penetration of zinc to the duration of exposure.

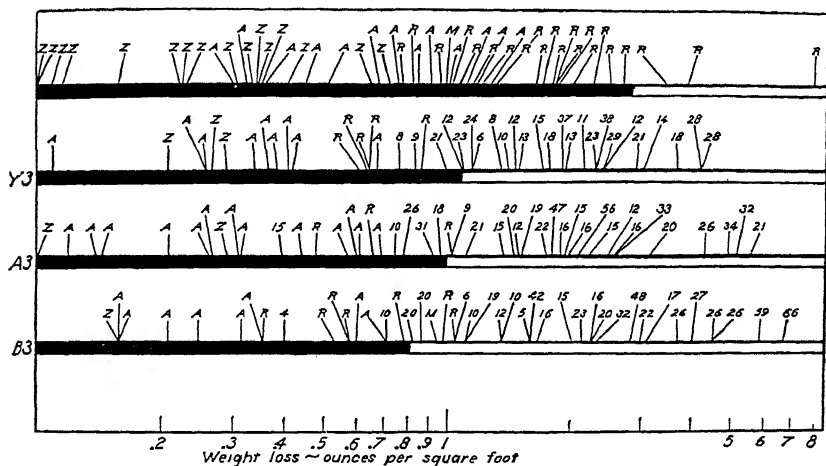
FIGURE 34.—Correlation between losses of weight and condition of galvanized specimens as determined by inspection.

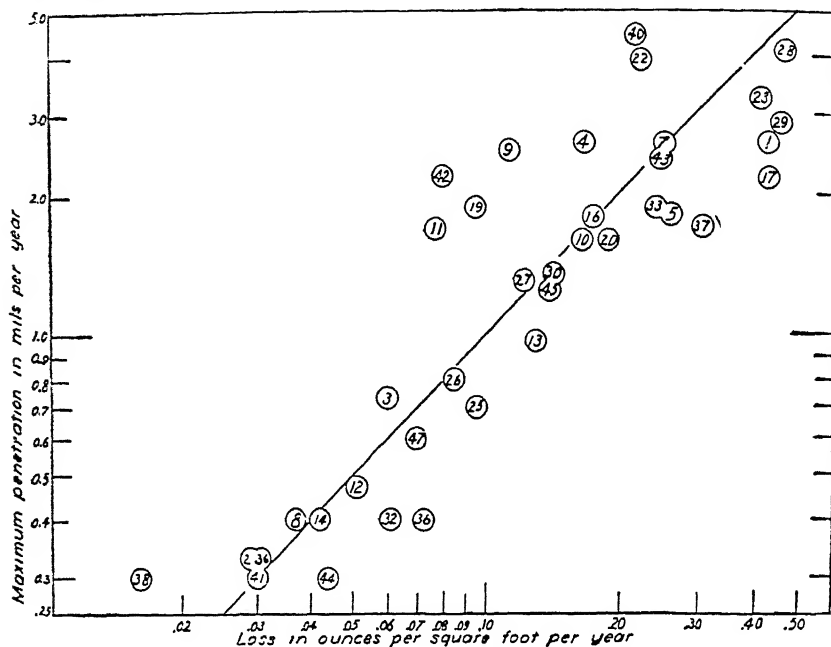
FIGURE 35.—Correlation between rates of loss of weight and rates of penetration on galvanized specimens.

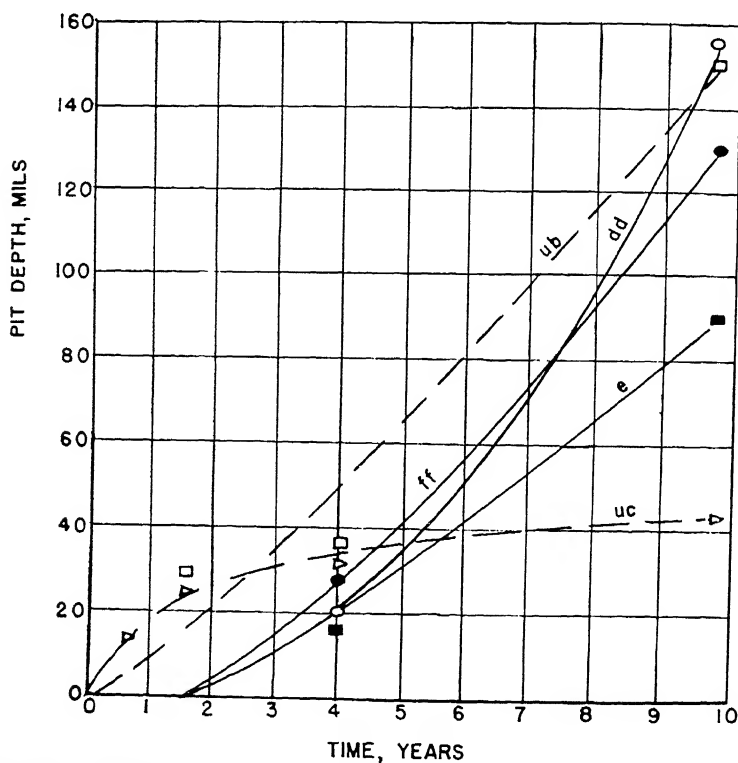
FIGURE 41.—Pit-depth-time curves for coatings applied to boiler tube at American Petroleum Institute site, XIII.—Miller clay.

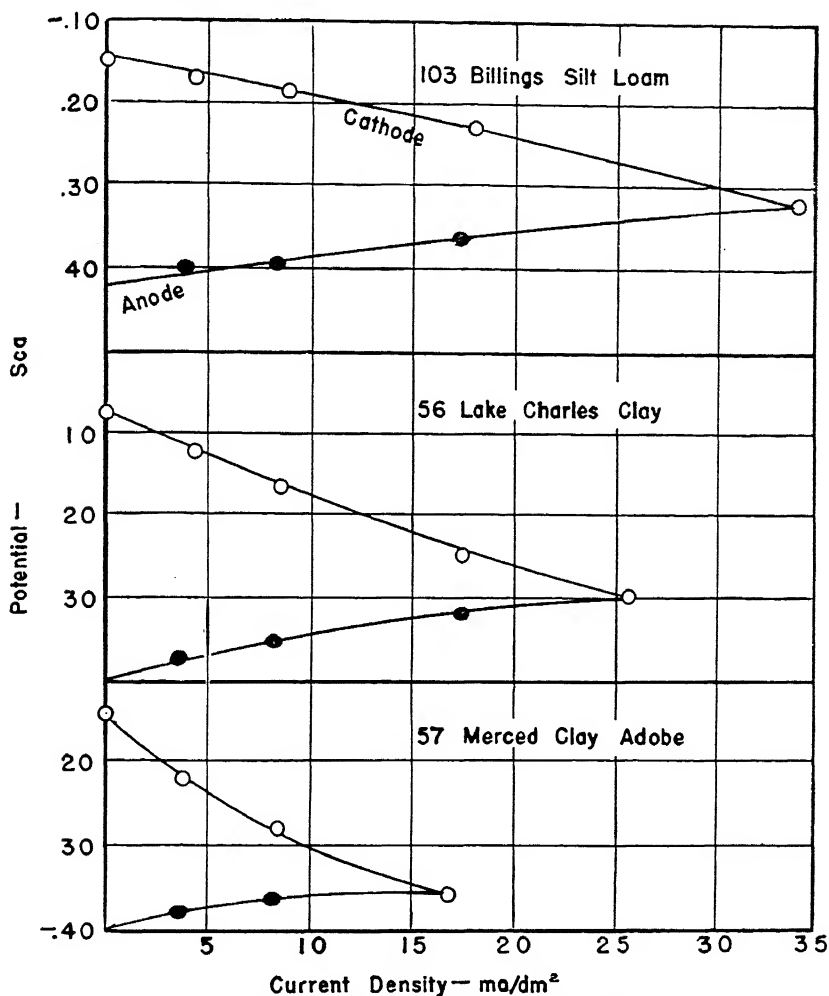
FIGURE 42.—Current-density-potential curves.

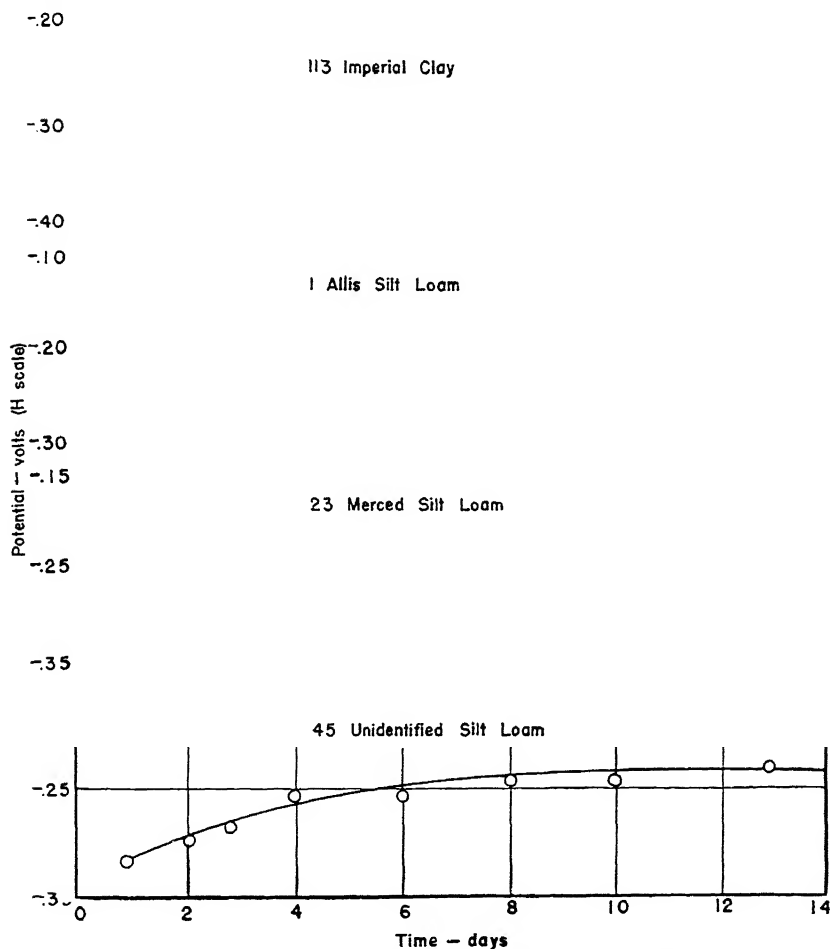
FIGURE 43.—Relation between corrosion potential and time.

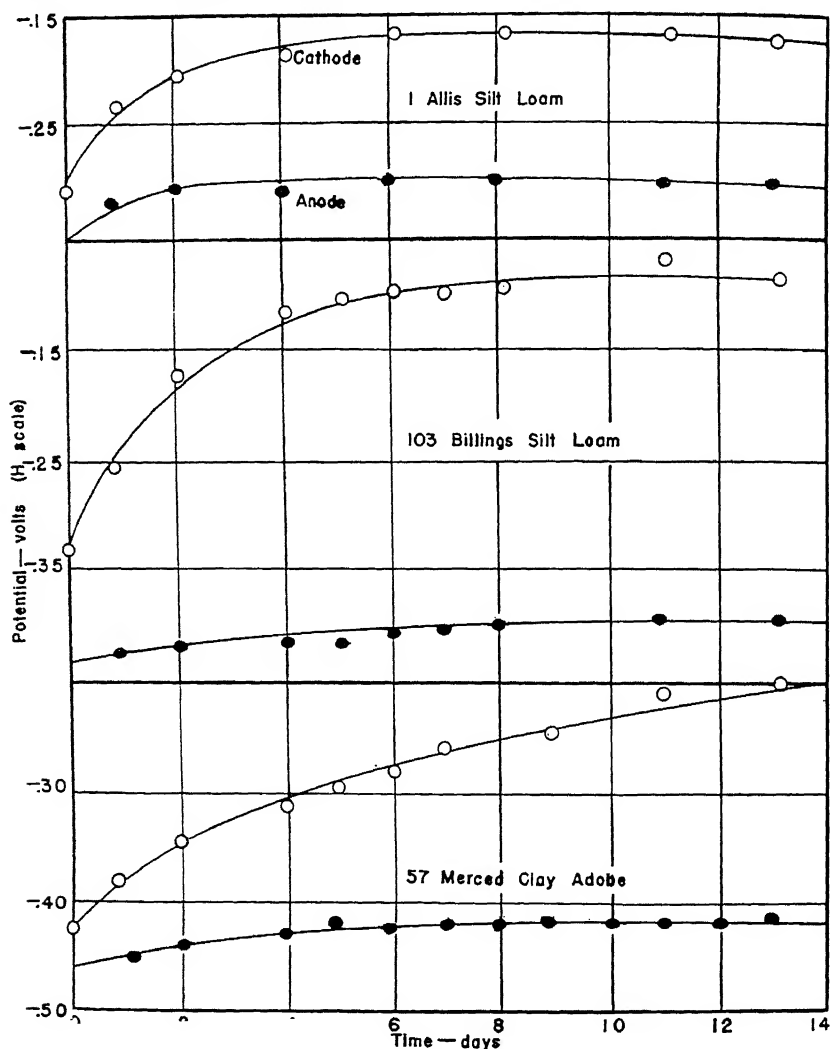
FIGURE 44.—Potential-time curves for the anode and cathode.

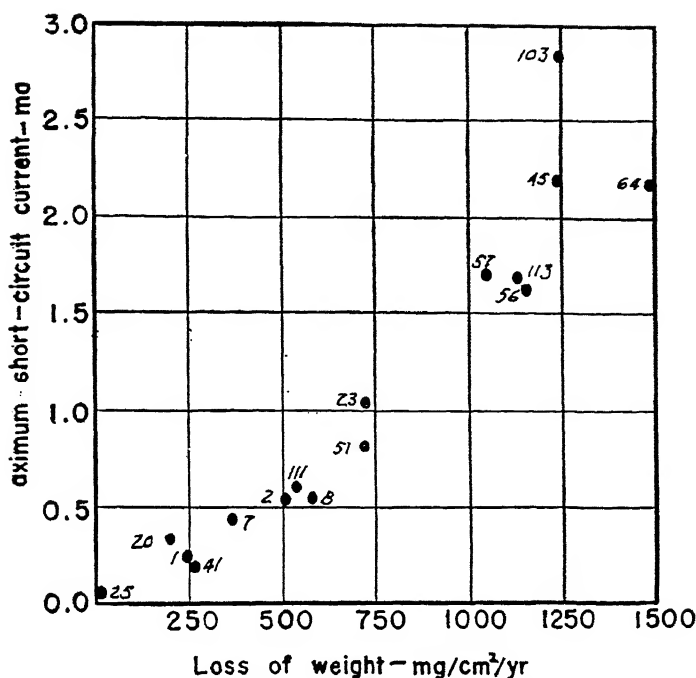
FIGURE 45.—Correlation between maximum short-circuit current and loss of weight of the anodes.

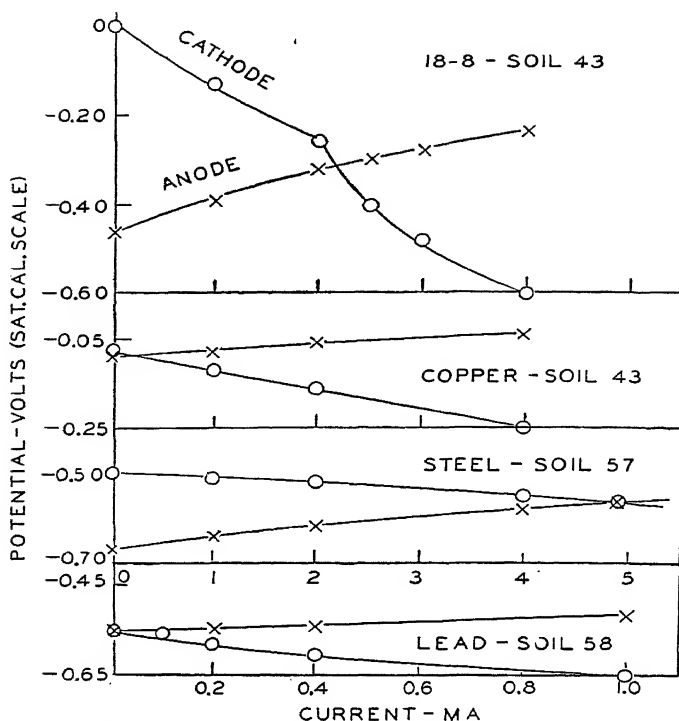
FIGURE 46.—Corrosion under cathodic control.

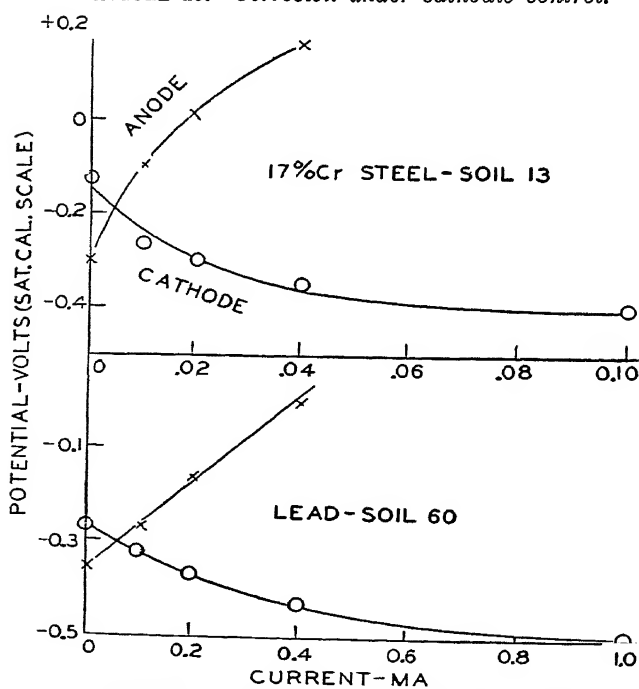
FIGURE 47.—Corrosion under anodic control.

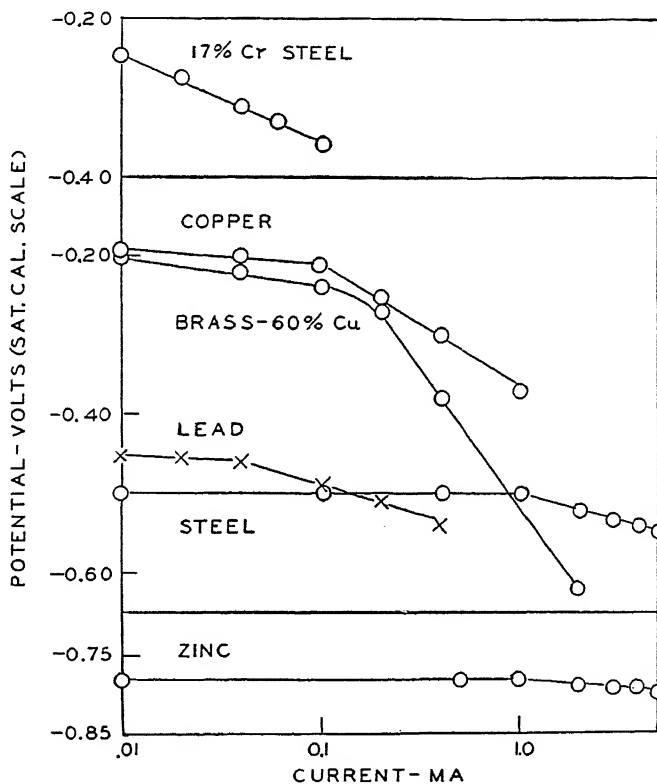
FIGURE 48.—Current-potential curves for the cathode in Docas clay.

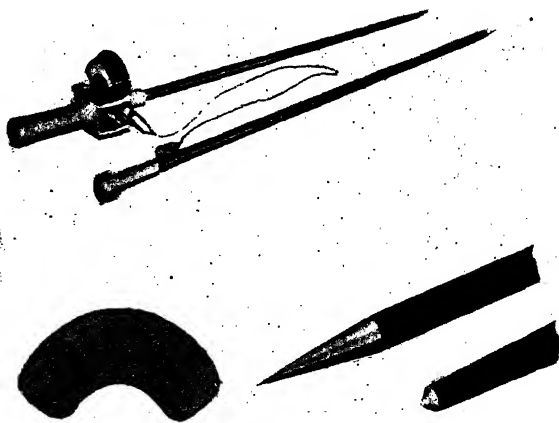
FIGURE 49.—*Shepard soil resistivity meter.*

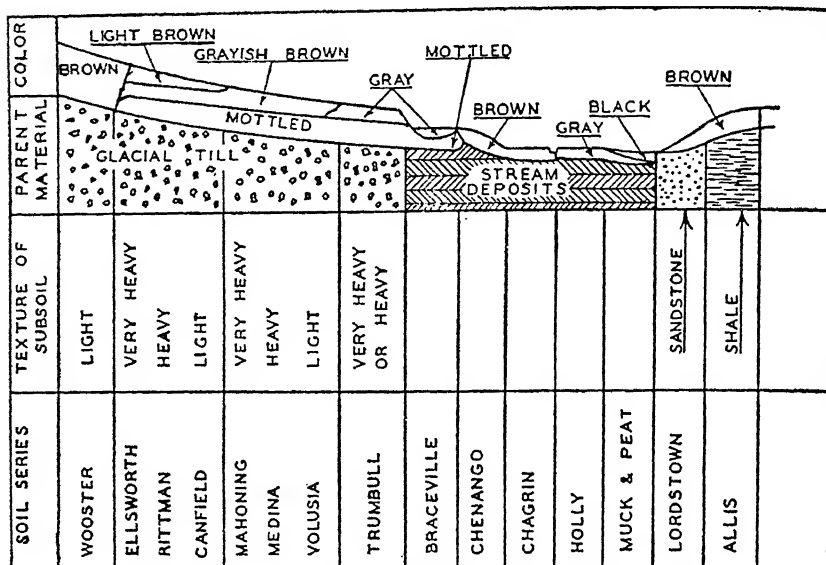
FIGURE 51.—Characteristics of soils in the regions of glacial sandstones and shales.

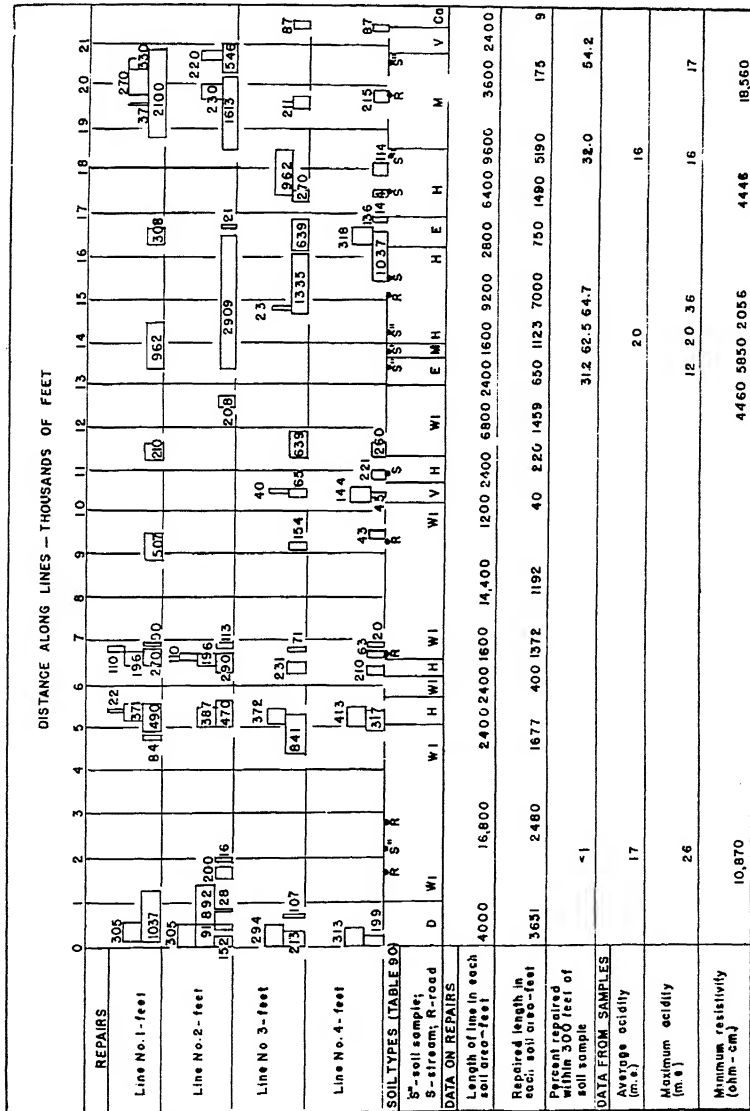
FIGURE 52.—Repair and soil data for typical sections of pipe lines.

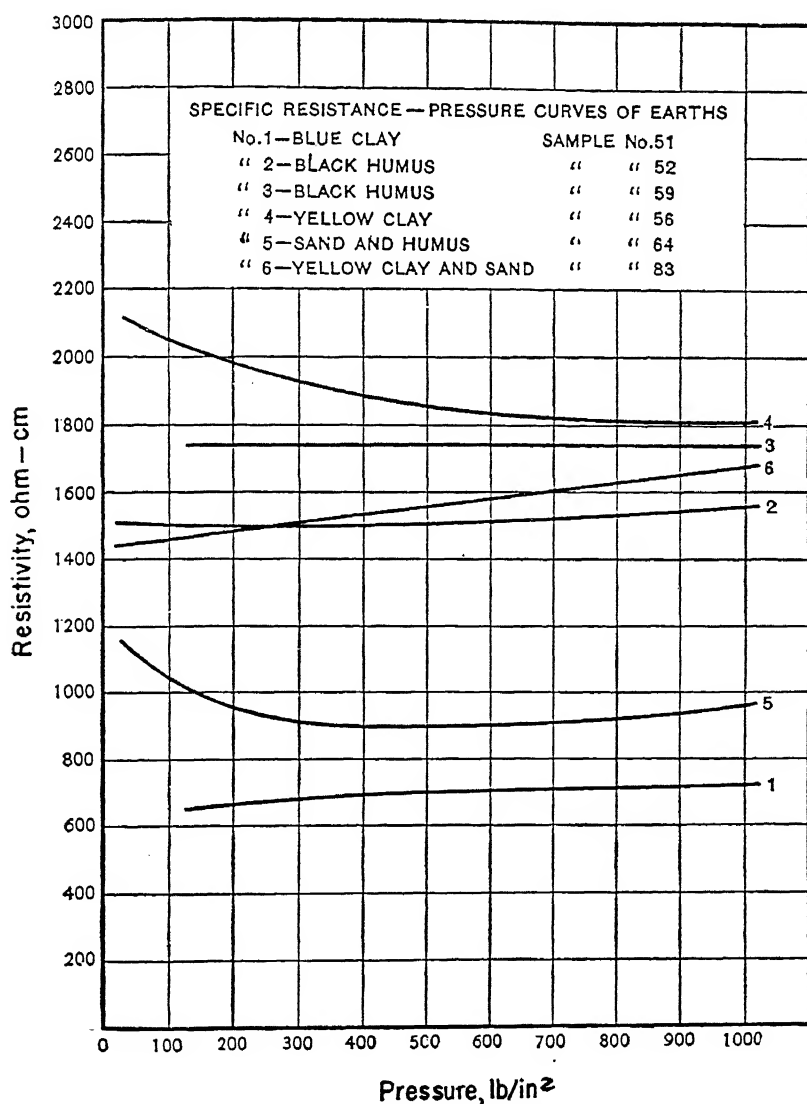
FIGURE 53.—Specific resistivity of soil at different pressures.

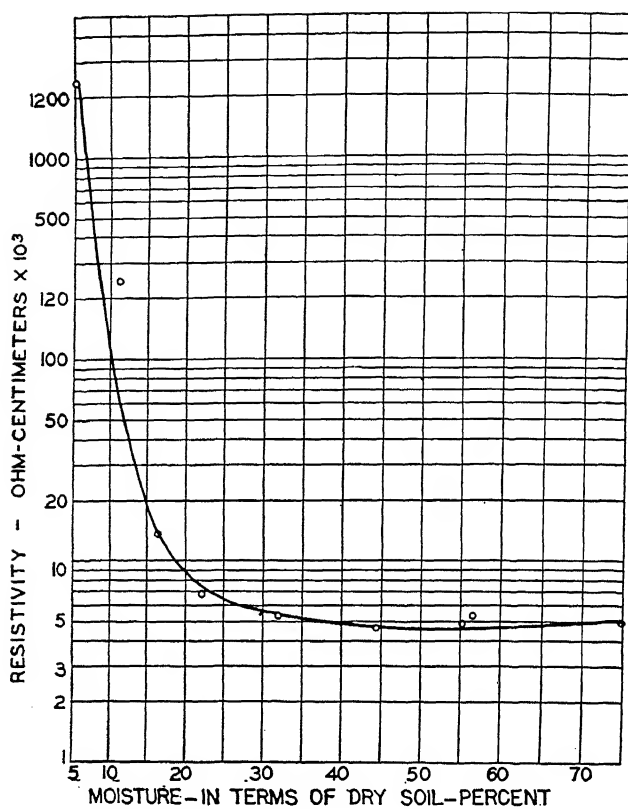
FIGURE 54.—Effect of moisture content on soil resistivity.

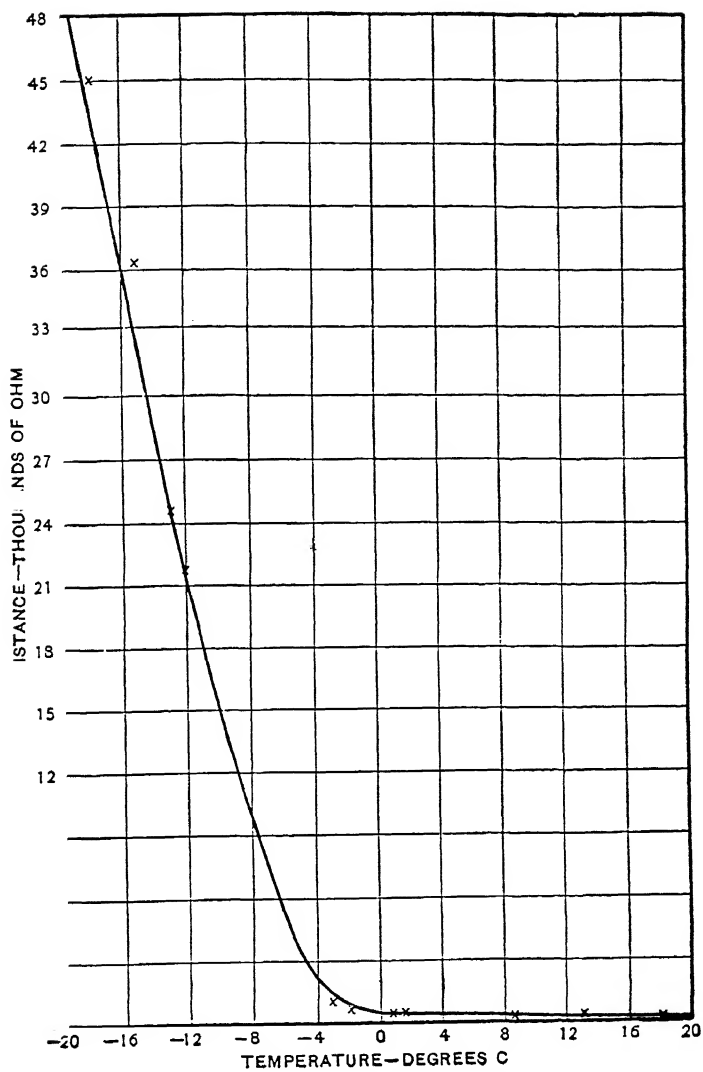
FIGURE 55.—Effect of temperature on earth resistance.

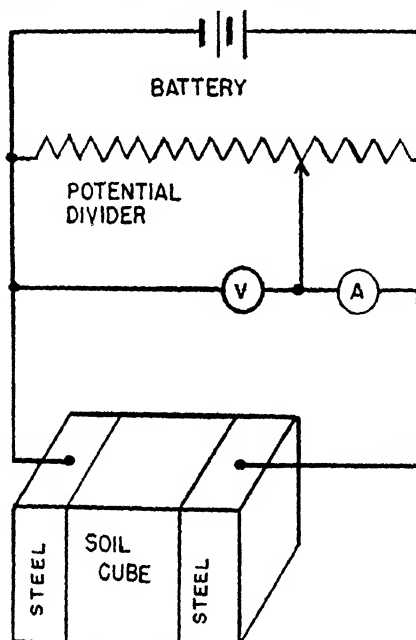
FIGURE 56.—Putnam apparatus for testing for potential corrosivity.

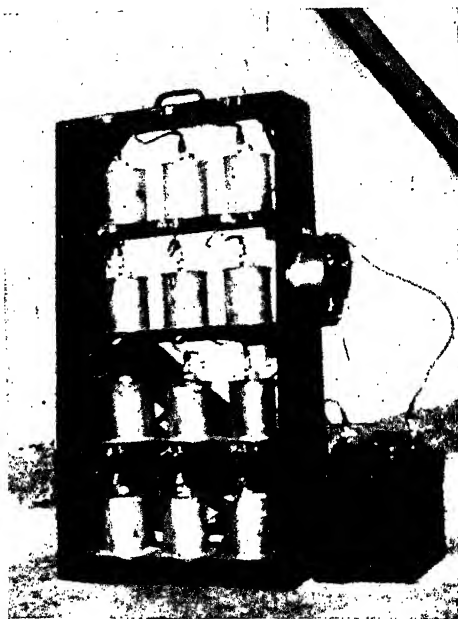
FIGURE 57.—Corfield apparatus.

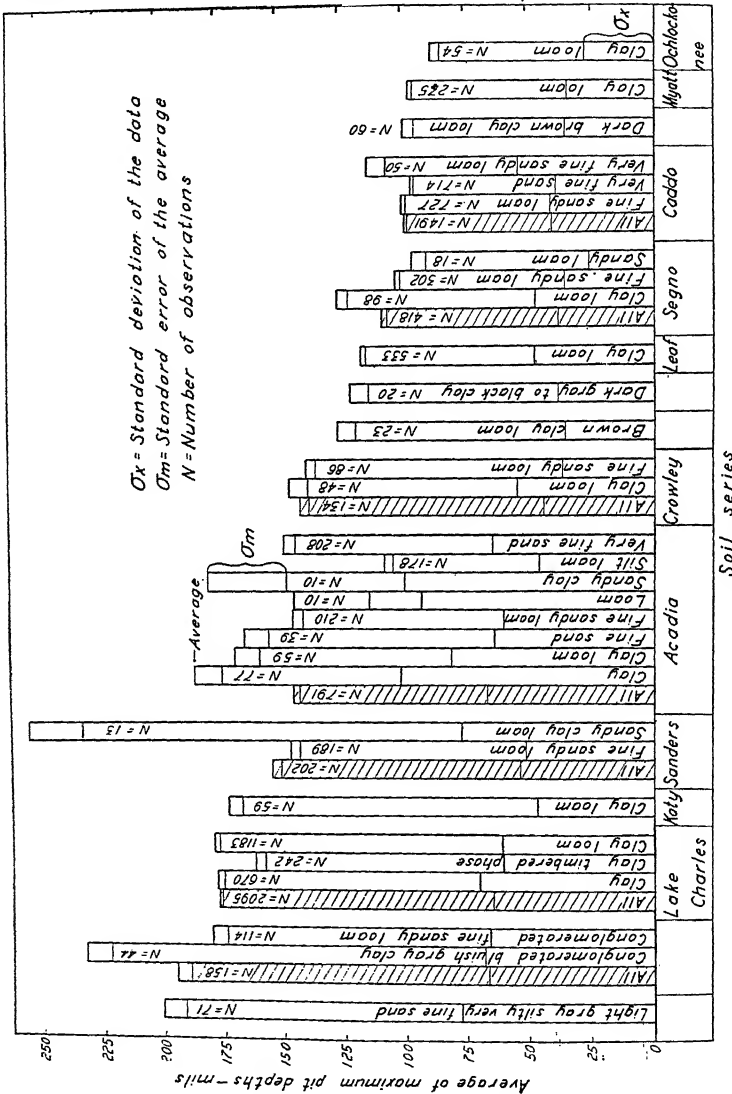
FIGURE 58.—Maximum pit depths on sections of pipe exposed to different types of soils.

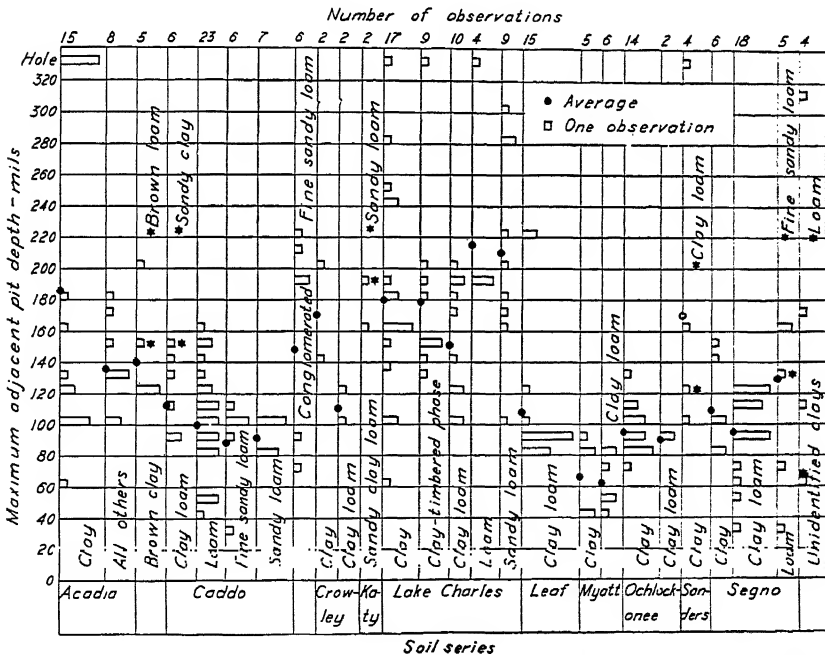
FIGURE 59.—Maximum pit depths on sections of pipe adjacent to places at which soil samples were taken.

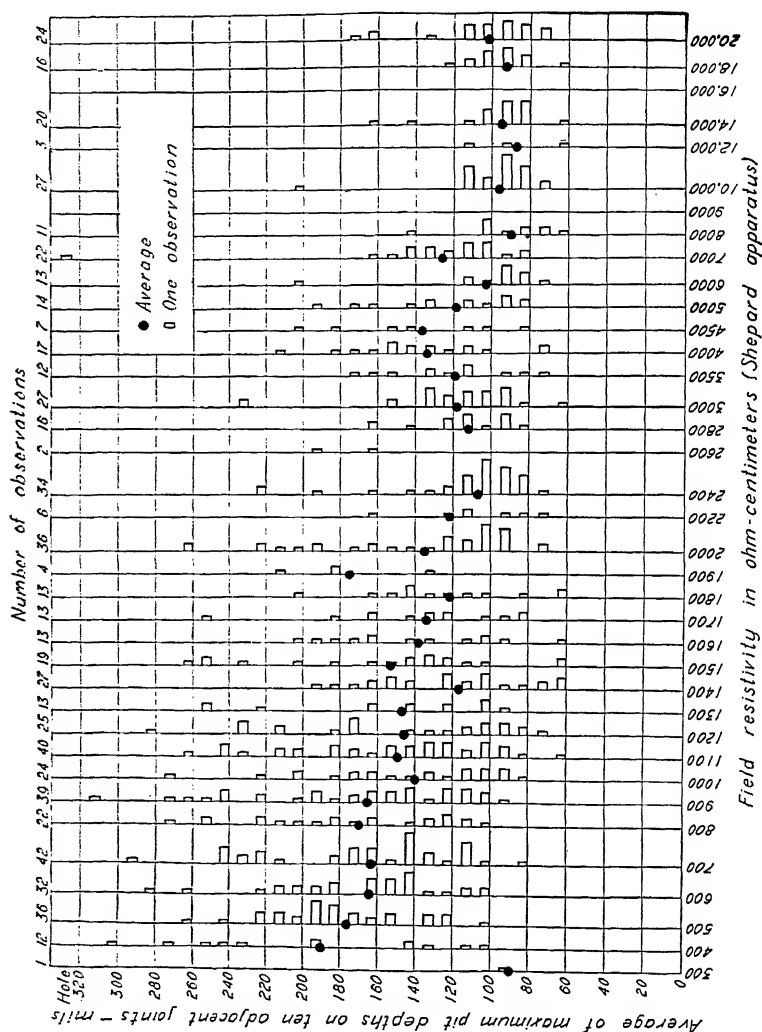
FIGURE 60.—Relation between soil resistivity measured in the field and the average of the depths of the deepest pits on the 10 sections of pipe nearest the place at which the resistivity was measured.

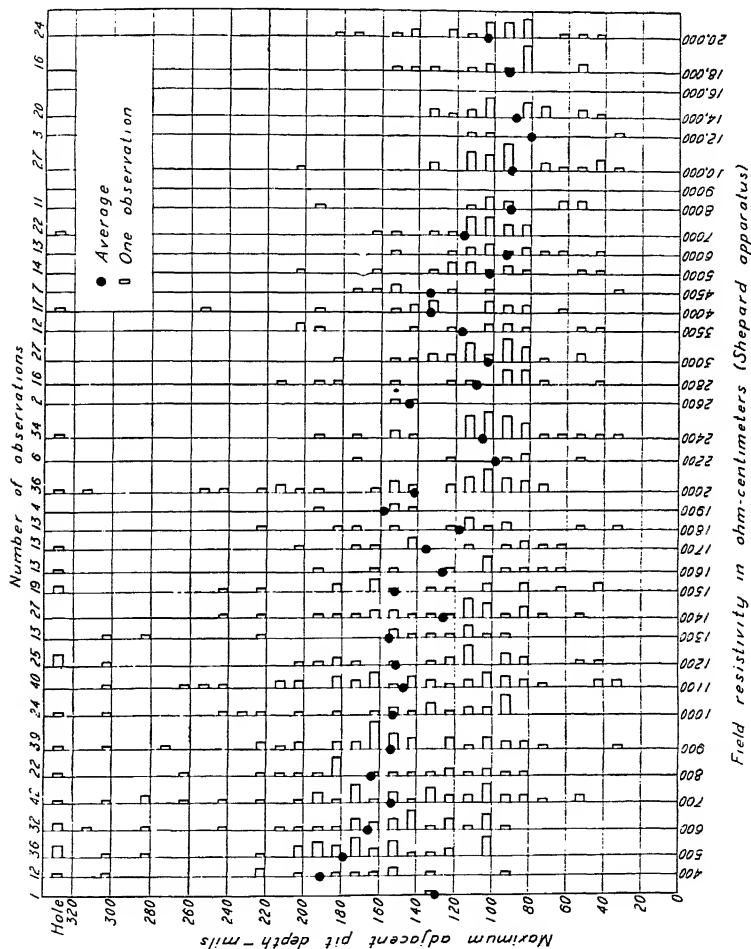
FIGURE 61.—Relation between the field resistivity of the soil and the maximum pit depth on a section of pipe nearest the place at which the soil resistivity was measured.

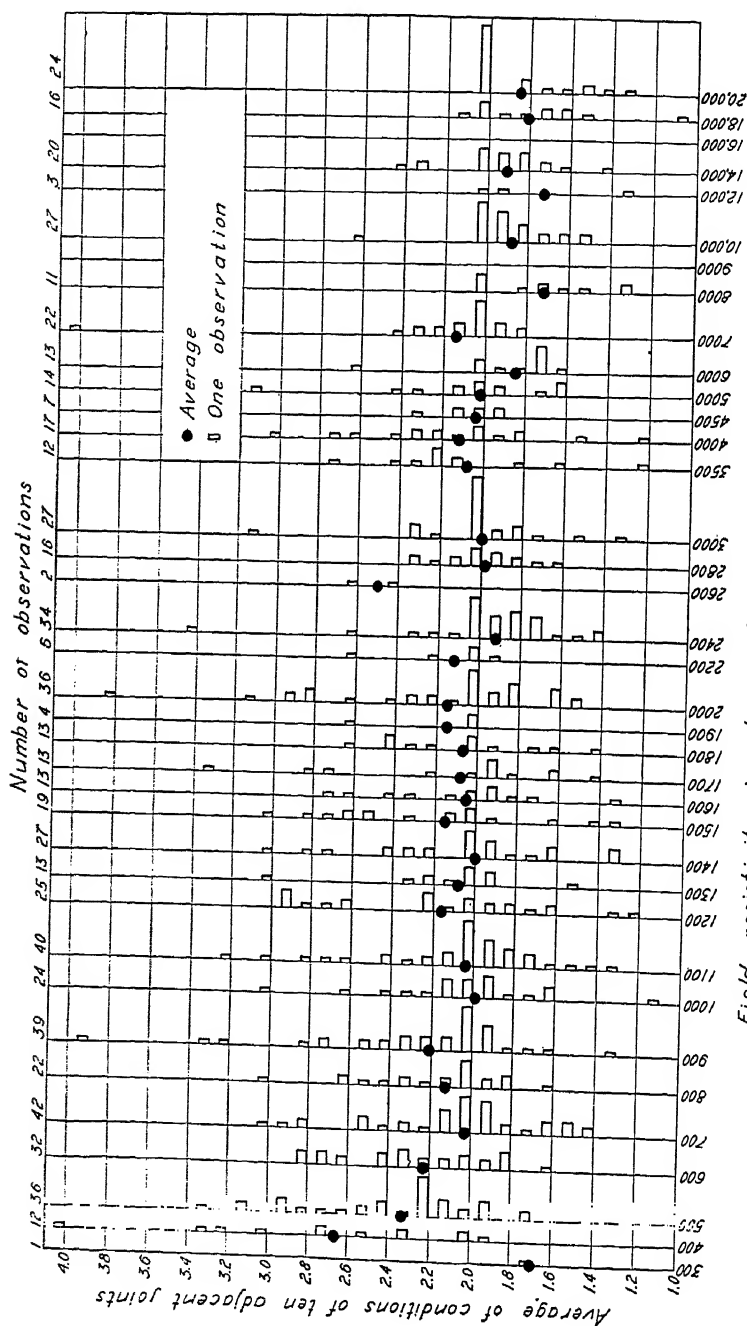
FIGURE 62.—Relation of the field resistivity of the soil to the average of the conditions of the 10 sections of pipe nearest the point at which the resistivity was measured.
The condition of the pipe was determined by visual inspection.

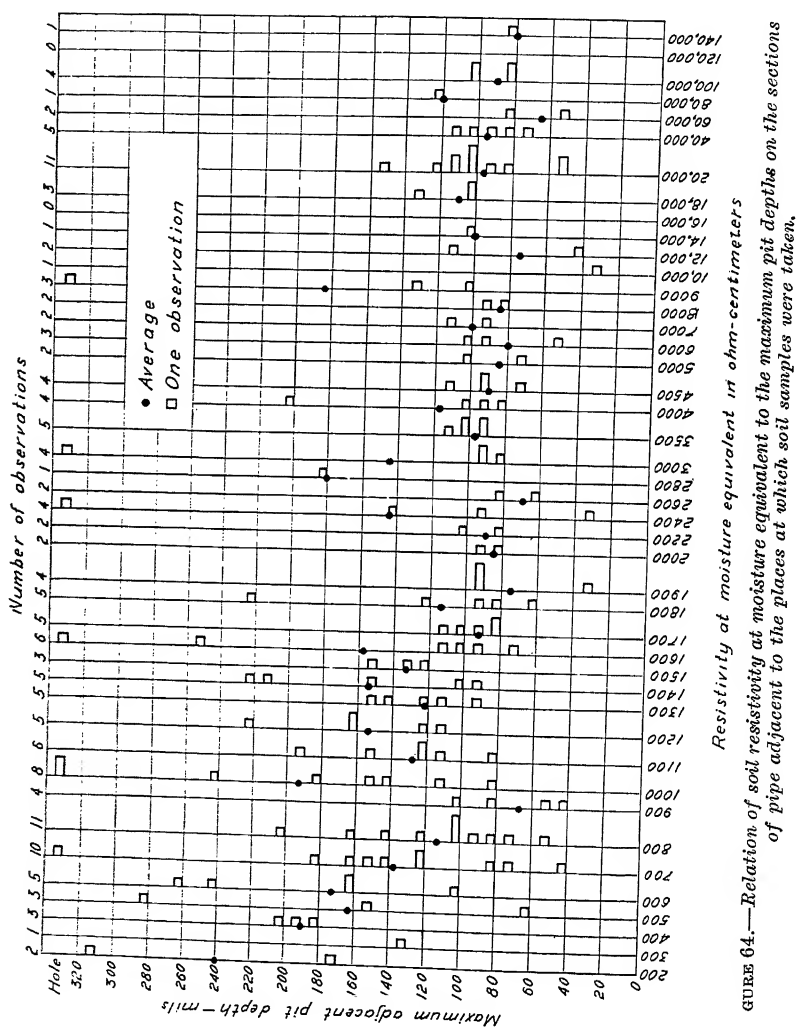
FIGURE 64.—Relation of soil resistivity at moisture equivalent to the maximum pit depths on the sections of pipe adjacent to the places at which soil samples were taken.
